TECHNICAL PAPER

Reverse Voltage Behavior of Solid Tantalum Capacitors

KYOCERA AVX Components Corporation
Paignton, England

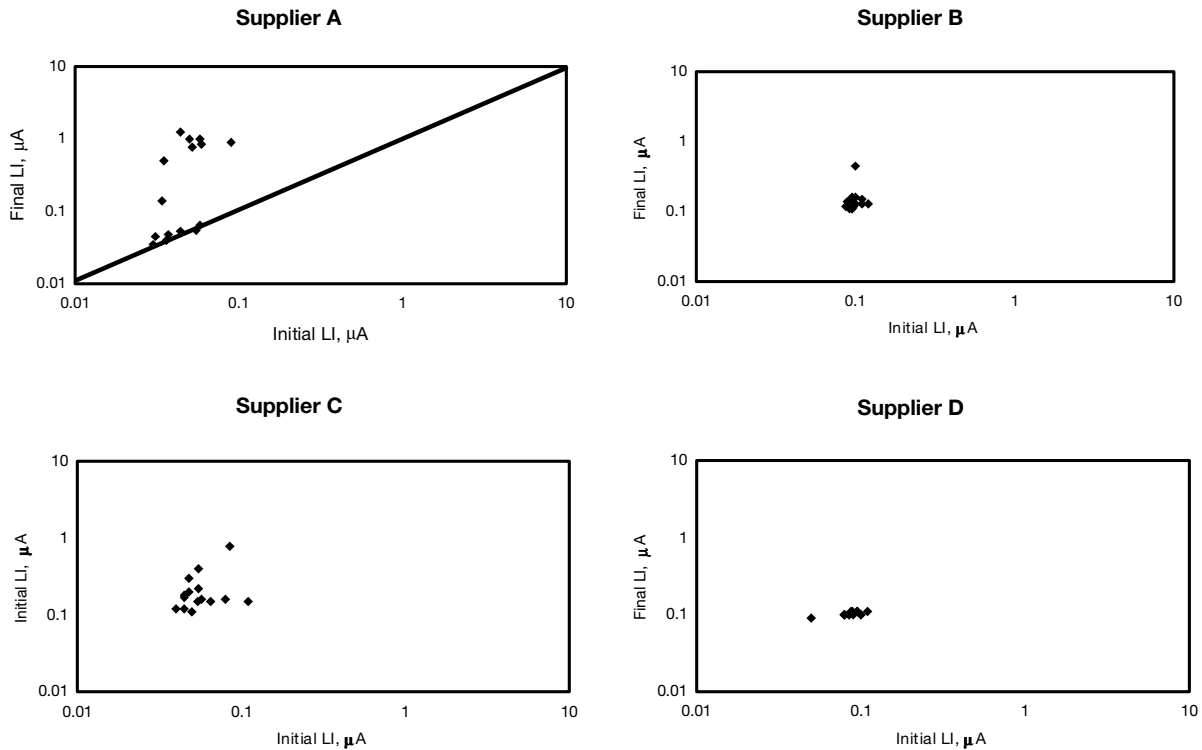
Figure 1

Some of the results of tests carried out for AVX are shown in Figure 1. This diagram shows the results from several manufacturers' 10 volt parts subjected to a 1 volt reverse bias (10% of rated voltage) for 48 hours at 85°C. The 45° sloping line on each chart is used to show a "no change" reference.

The results show that while there are some differences between manufacturers' initial leakage distributions, all experienced some increase in leakage current. They also show that for all manufacturers, parts with a low initial

leakage current were as likely to increase their leakage current as units which had a higher initial leakage current. This observation is however, similar for parts tested in the forward direction.

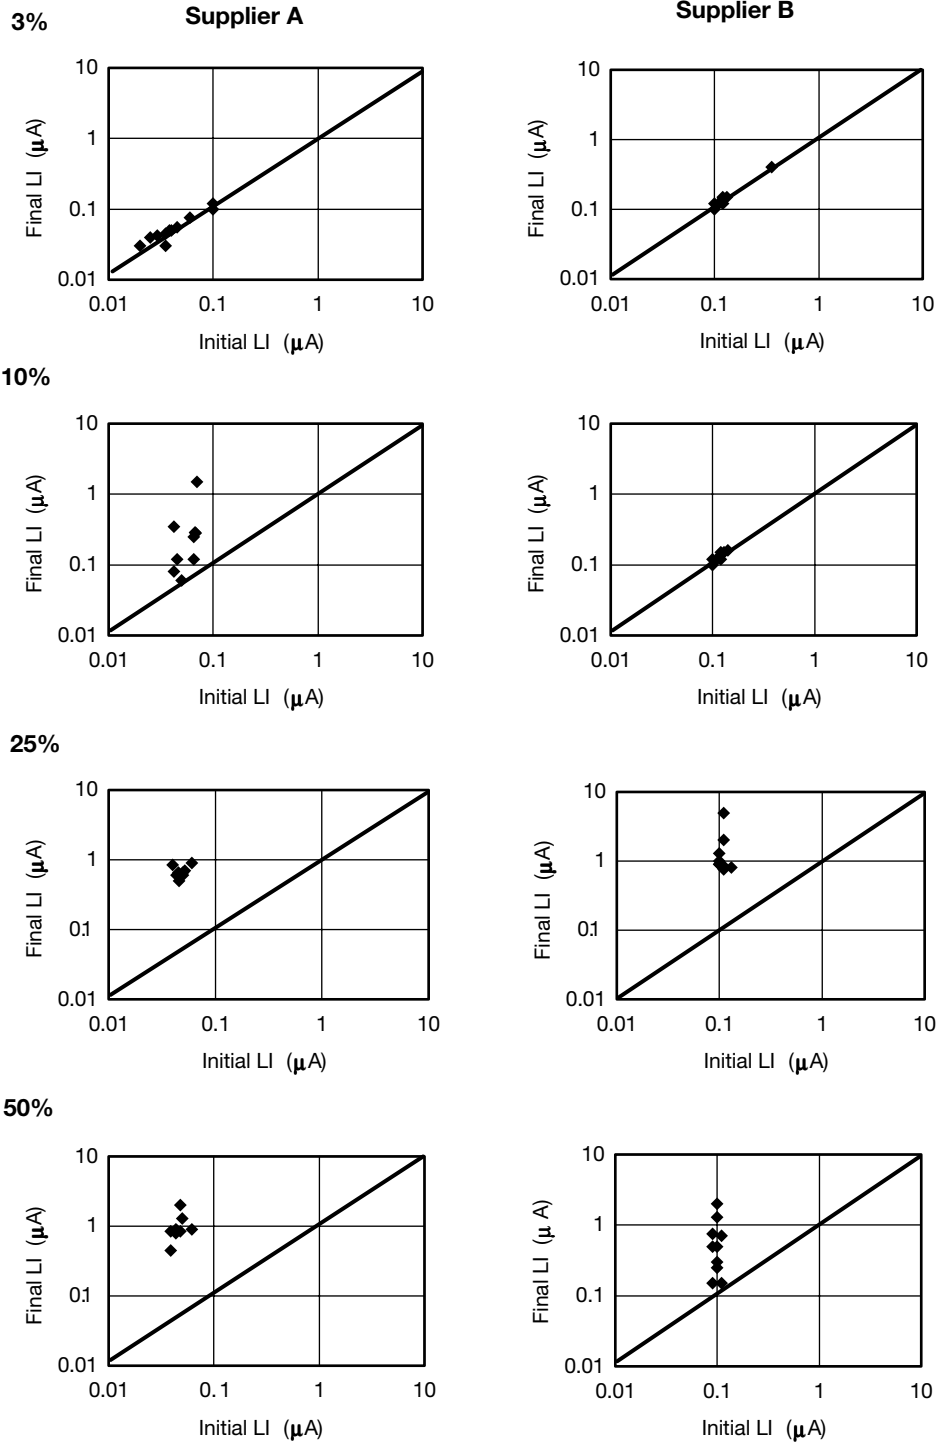
Figure 2 shows the results of experiments carried out on two manufacturers' products where the test voltage was varied from 3% to 100% of rated volts. The other test conditions were as in section 4.2. As can be seen the higher the reverse voltage applied the greater the average increase in the leakage current of the capacitor.

The table in Figure 2 indicates that at rated voltage in reverse, all the parts from two manufacturers failed, blowing the series protecting fuse.

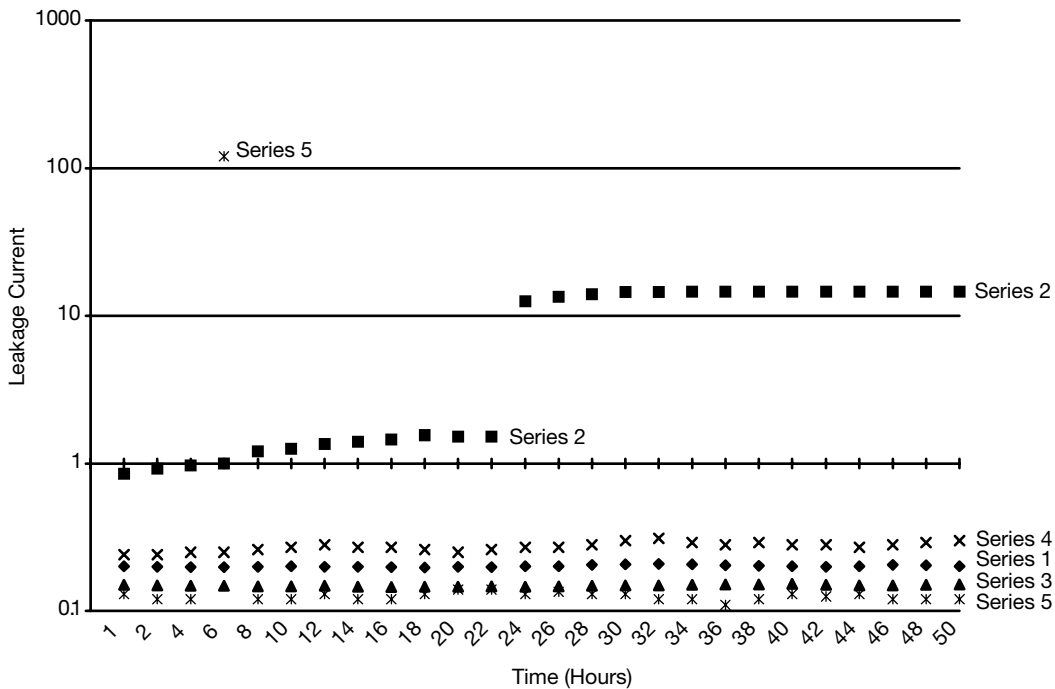
Figure 3 shows the current passing through several 10 volt tantalum capacitors subjected to a reverse bias of 1 volt at 85°C for 48 hours with an external resistance of 2.7kΩ. As can be seen, the behavior of the units varies quite considerably, with some units exhibiting a slow increase in the level of current passing, but others exhibiting sudden changes in current. Note especially the behavior of unit 5 which experienced an apparent short circuit at 10 hours

but then recovered to a more normal level.

Results have shown that this is extremely inadvisable. Application of the correct polarity to a unit which has been subjected to reverse voltage can sometimes appear to heal the capacitor, but this does not always occur as shown in section 4.4. The safest option is therefore to replace any capacitor which was connected in reverse polarity. While the majority of units recover to normal levels (see Figure 3), some units continue to exhibit abnormal behavior. Figure 4 shows the results of applying forward voltage to the units from the experiment in Figure 3 at 85°C and rated volts for 24 hours. As can be seen, unit 5 becomes very low resistance twice. If the circuit impedance were low, such a condition could result in the capacitor becoming a short circuit.

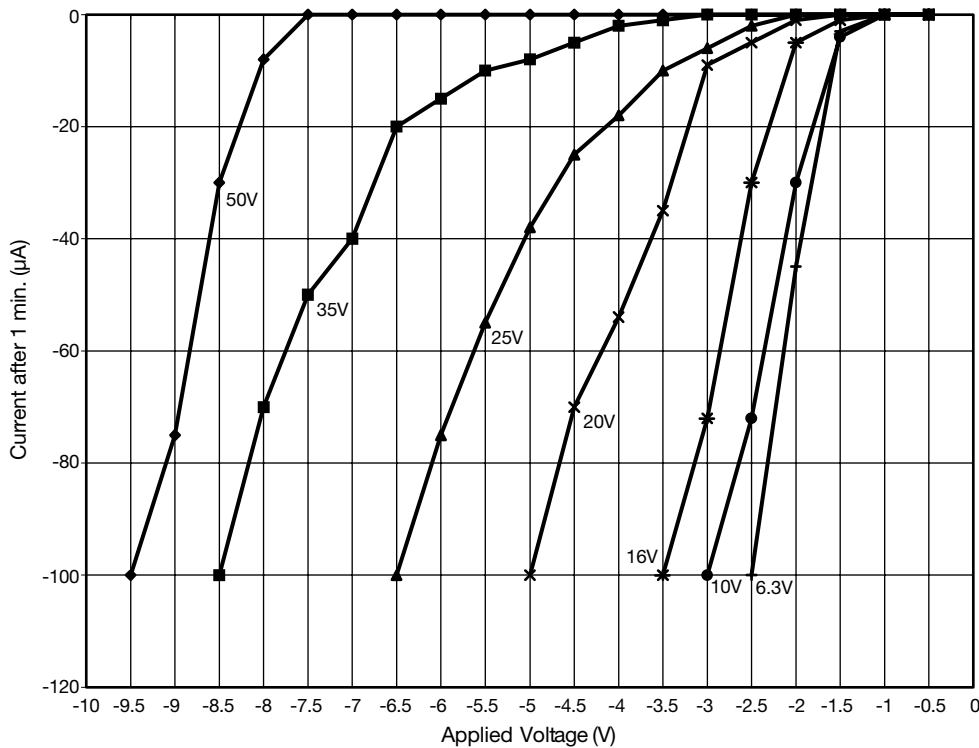
Another simple option is to use a higher voltage rated capacitor than is normally necessary. Figure 5 shows typical leakage currents for various rated capacitors under reverse voltage, and indicates that the higher the rated voltage of the capacitor, the lower the current during reverse orientation.
